Cultural Resource Evaluation Report for Mt. SAC SEIR for 2015 Facilities Master Plan Update and Physical Education Projects, Walnut, Los Angeles County, California

April 2016

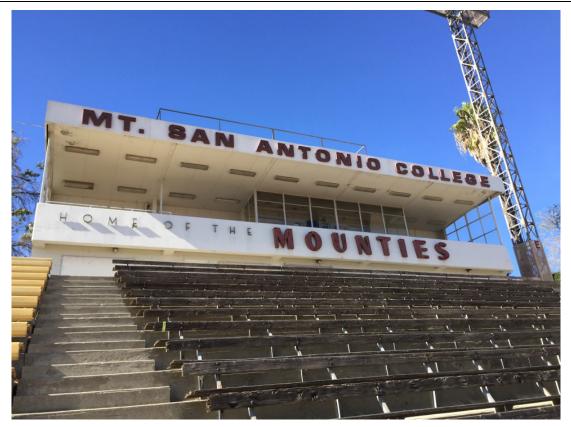
Figure 7. Press box (50F), view looking west of east façade.

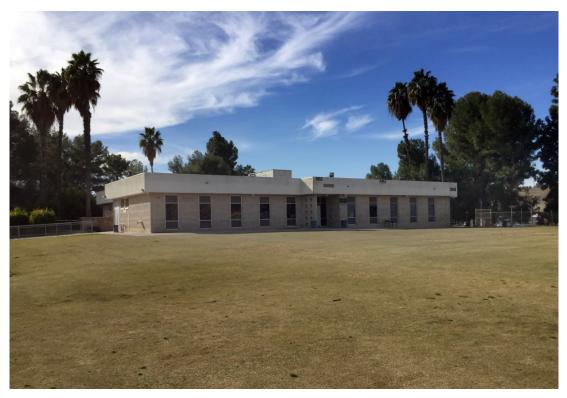
Figure 8. Field House (50G), view looking southeast of east and north façades.

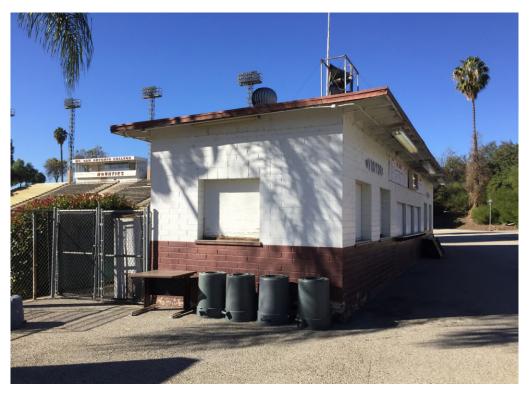
Figure 9. Concessions building (50H), view looking west of east and north façades.

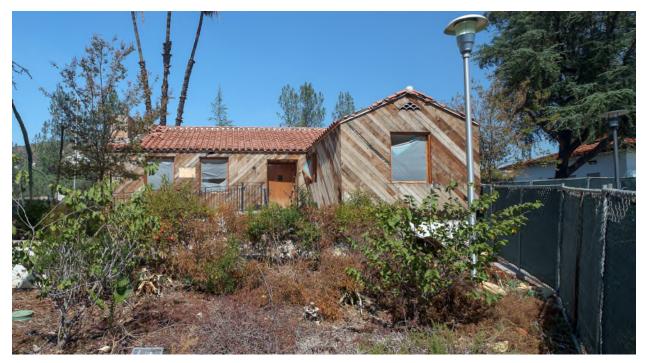
Figure 11. Oden House (12A) and garage (12B) to the right, view looking north at south façade.

Buildings 12A/B were constructed in 1947 as a single-family residence in the Spanish Colonial Revival style (Figure 11). They served as the residence for the college's first campus maintenance supervisor. According to the 2003 Gregory DPR form, the building is referred to as the "Oden House," presumably named after the first college maintenance supervisor; however, no other documentation or mention of this name is given in the report or DPR (Gregory 2003). Building 12A is the residence. Building 12B is believed to have served as a garage for the residence, but unusually contains a vented cupola at the top of the hipped roof that housed a siren.

Oden House is located in the northwest part of the campus, south of Edinger Way and Walnut Drive. At the time of the survey, the building was vacant and in a partial state of demolition. The single-story building has a concrete foundation and a T-shaped footprint. It was covered in stucco prior to partial demolition. The exterior siding at the time of the survey consisted of diagonal wood boards that were originally used as lathing for the stucco exterior. The roof is cross-gable with shallow eaves and is clad in red clay tiles. Concrete steps with an iron railing lead to the primary entrance which is located within the northeast corner of the south façade and consists of a recessed entrance with a wood door. Since demolition began, the windows have been removed. Originally they consisted of wood casements. Other features of the building include bird's nest vents made of red clay tiles located under the apex of the gable end projections. The building has a chimney on the west gable end lateral interior. The interior of the building consists of wood floors, plaster walls, arched entryways, pocket doors, and exposed beams on the ceiling. The building plan consists of eight rooms (Oden House 1999).

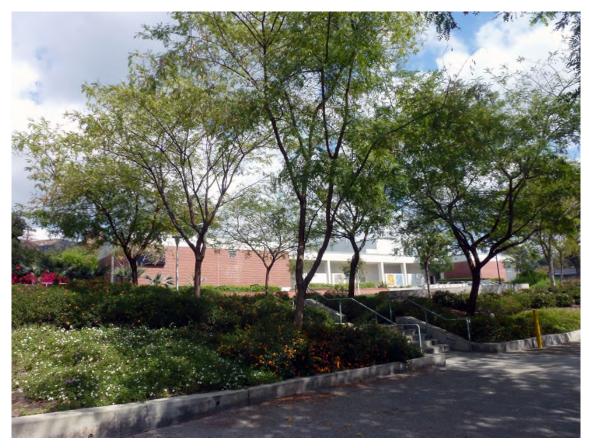
Figure 12. View of the south façade of Building 1A.

Building 1A, the Art Center, was constructed in 1972 (Figure 12). The Modern single-story building has a rectangular floor plan and concrete foundation. The educational building has brick and poured concrete siding and a flat roof. The windows are primarily fixed steel and are located on the north façade. Concrete steps with metal railings lead to the primary entrance on the south façade that consists of a partial-width arcade with rectangular concrete columns. At the center of the walkway within the arcade is a large glass display case flanked by walls of built-in lockers. In between the columns of the arcade are large concrete bulkheads adorned with geometric mosaics facing south; the north sides of the bulkheads have built-in lockers. Within the arcade are five entrances consisting of flush metal doors, some with partial glazing.

On the north, the façade consists of a poured concrete exterior with squared pilasters. In between the pilasters are boarded-over window openings with small partitions in between. Above the row of boarded-over windows are rows of steel-framed windows. Some classroom entrances are located on this façade, as well as a recessed porch entrance with mechanical equipment within. There is a kiln for the ceramics department located on the east façade within a walled partition. Secondary entrances are located on the east and west façades.

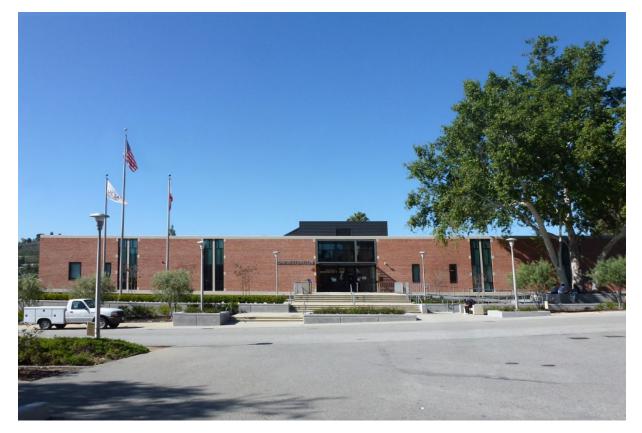
Figure 13. View of the primary (west) façade of Building 4.

Building 4, the Administration building, was constructed in 1965 in the Modern style (Figure 13). It is a two-story building located on the northeast of Temple and Grand avenues on the southwest side of the Mt. SAC campus. The administration building has a rectangular footprint with a concrete foundation. The upper portion of the building's exterior is clad in brick with scored concrete siding on the lower portion of the building. The brick is laid in three sections of running bond with a single sailor course in between each section. The concrete on the lower portion of the building is scored in a grid pattern. The roof is flat and has a poured concrete parapet cap. There is a penthouse on the roof that houses mechanical equipment. The primary entrance is located on the east façade and consists of a centrally-located recessed aluminum and glass entryway with a steel canopy over the double doors that have steel beams and accommodates lighting fixtures at the ceiling of the entryway. A secondary entrance is located on the north façade where a non-original steel canopy has also been installed. The south and west façades also have secondary entrances located within the lower portion of the building that has scored concrete siding. These entrances, like the east and north, consist of aluminum-framed glass entryways.

Modifications to the building include two additional fixed windows on the north façade, four additional fixed windows on the east façade, the steel post and beam framing and canopy on the east entrance, the canopy on the north façade's entrance, and the addition of five windows on south façade. According to original building plans, the narrow paired windows on the north and south façades were originally filled in with colored glass block windows, and have since been replaced with fixed metal windows. The interior of the building consists of carpet and tile floors, squared columns and a designed angular, cut-out ceiling. The building retains high integrity of material, location, setting, and association. The building has lost some integrity of design and workmanship with the installation of a number of additional windows that change the fenestration of the building. The building retains sufficient overall integrity.

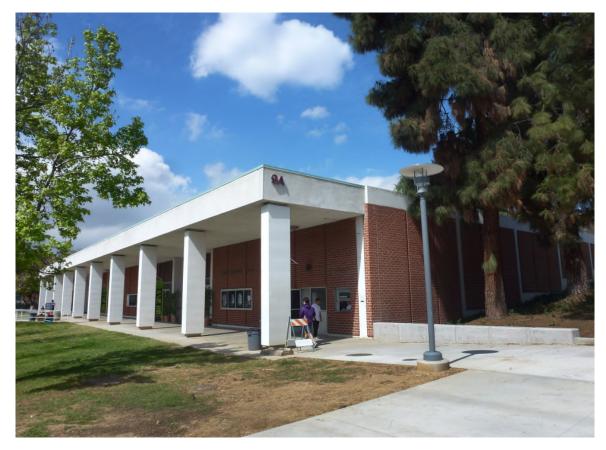
Figure 16. Oblique view of the south and east façades of Building 9A.

Building 9A, the Bookstore, was constructed in 1969 in the Modern style (Figure 16, previous page). It is a single-story educational building located on the northeast side of Temple and Grand avenues on the west side of the Mt. SAC campus. The bookstore has a rectangular plan with a concrete foundation. The exterior is clad in brick siding with vertical concrete post inlays. The roof is flat with concrete parapet caps. The primary entrance is located south façade and consists of a full-width porch canopy made of a poured concrete roof and squared posts. Within this arcade are three recessed entrances surrounded by sidelights and transom windows. There are also two illuminated display cases built into the wall plane as well as two pass-thru counter windows on this façade. There is a secondary entrance located on the west façade that has a metal canopy and a mosaic tile wing wall covering part of the recessed entrance. On the north façade is a sloped driveway that leads to a loading dock. Modifications to the building include replacement doors. The building retains integrity of materials, design, workmanship, feeling, association, setting, and location.

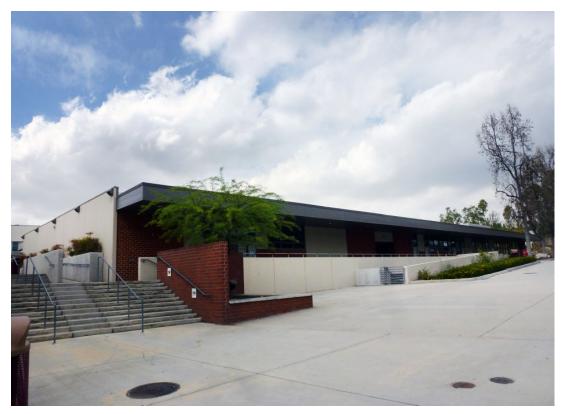
Figure 17. Oblique view of the east and south façades of Building 11.

Building 11 was constructed in 1960 as the second unit in a new physical science complex on the Mt. San Antonio College campus (Figure 17, above). Building 11 is a generally L-shaped one-story Modern educational building with a basement. A lower, windowless addition at the southwest tip of the building is clad in smooth stucco. The building primarily has brick and smooth stucco cladding and a flat roof with no eaves. A wing wall at the southeast façade of the main wing is clad in smooth stucco with widely spaced scoring. Deep, flat metal-clad cantilevered roofs shelter the open passageways extending across the

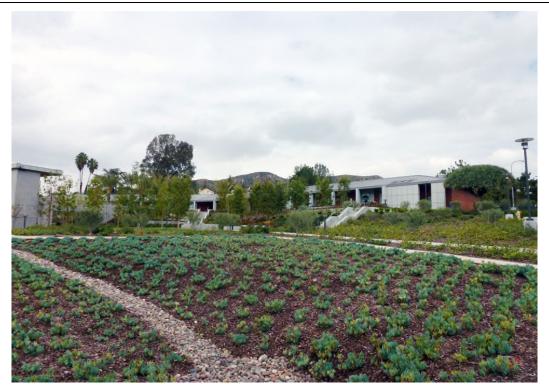
Figure 18. View of the south façade of Building 12.

Building 12, the Counseling Support or North Hall building, was constructed in 1963 in the Modern style (Figure 18). It is a single-story educational building located on the located on the northeast side of Temple and Grand avenues on the west side of the Mt. SAC campus. The building has a V-shaped plan with a concrete foundation. The exterior is clad in brick siding. The roof is a low-pitched hipped roof with overhanging eaves and clad in metal. The primary entrance is located within a full-width recessed arcade on the south façade and consists of several doors that lead to offices and classrooms. The porch arcade is supported by large rectangular columns of scored concrete. The doors and windows have been replaced since the building's original construction and consist of metal-framed opaque windows and doors. There is a central breezeway that leads to the rear of the building, which has a parking lot. The north façade of the building along the rear of the ridgeline along the roof. Modifications to the building include the replacement of doors and windows and roofing material. According to original building plans, the roof was made of tile, and the north façade did not have windows. Landscape features include a concrete central courtyard to the south of the building with planting beds and a central walkway. These modifications have resulted in significant loss of integrity of materials, design, workmanship, feeling, and association.

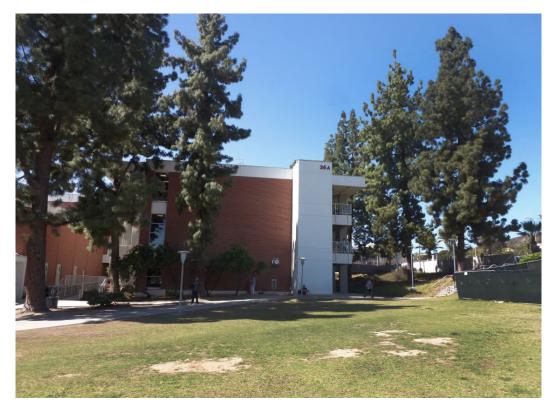
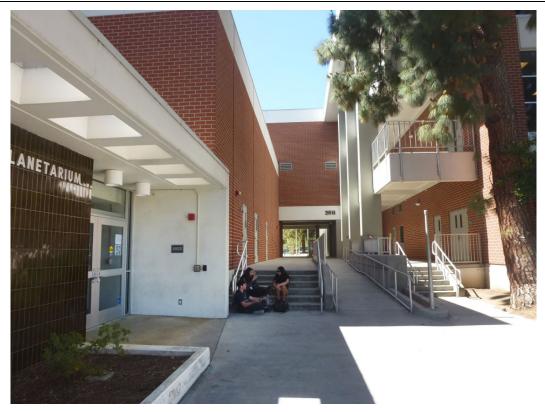
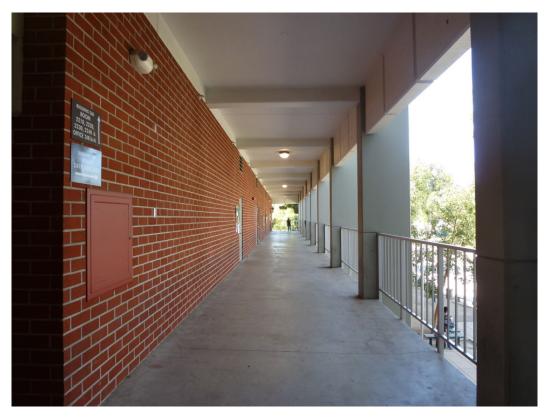
Figure 19. View of the east façade of Building 26A.

Figure 20. View of the breezeway between Buildings 26A and B.

Figure 21. View of the second story corridor of Building 26D.

Buildings 26A, B, and D (Humanities North, Humanities East, and Humanities South, respectively) were constructed in 1967 as a complex of educational buildings for the humanities (Figures 19-21). The Modernstyle buildings have flat roofs and are clad in red brick with a wide band of poured concrete at the top and base of the buildings. Because of the grade of the site, the complex is three stories in height at the north and four stories at the south. The three buildings are arranged in an H shape, forming a courtyard at the west and an area to accommodate Building 26C (the Planetarium) at the east. The buildings are connected by continuous open passageways. A series of regularly spaced rectangular concrete columns extend from the ground level to the roof, and metal railings span the distance between the columns. The floor of each passageway at the highest level. The complex has interior staircases at each end of the two larger buildings; at the west façades, elevators are housed in scored-concrete elements that project from the brick façade of the building.

The focal point of the complex is the spacious landscaped courtyard. At the east end of the courtyard is a three-story suspended concrete staircase anchored by a multi-story curved brick-clad pylon. At the center of the concave side of the pylon is a dramatic modern clock with stylized numbers and hands separately mounted on the façade.

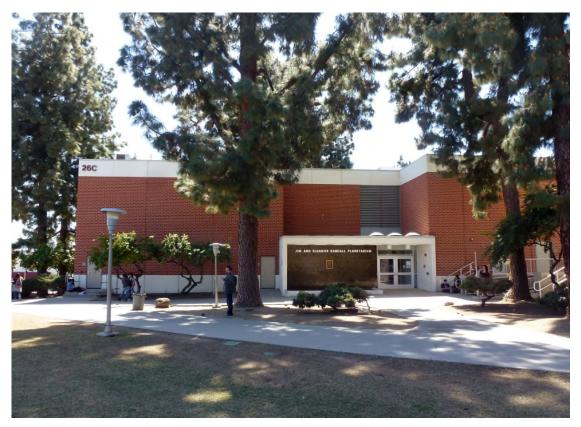
Figure 22. View of the south façade entrance of Building 26C.

Building 26C, constructed in 1967, houses the Planetarium (Figure 22, above). It is associated with the Humanities complex (Buildings 26A/B/D) and is stylistically similar. Building 26C is a Modern one-anda-half-story building with an irregular floor plan. The nearly flat roof of the building extends slightly upward toward the east. At the west end, it is physically connected to Building 26B, and it intrudes on the space between Buildings 26A and 26D without touching. Building 26C is clad in red brick with a wide band of poured concrete at the top and base. The exterior walls are vertically scored. Two identical primary entrances are aligned with each other at the north and south façades. The primary entrances are inset into the main mass of the building and are defined by a projecting one-story poured-concrete frame with two square cut-outs on one side and a concrete planter box below. Individually mounted aluminum letters reading "Jim and Eleanor Randall Planetarium" is mounted on a wall of rectangular, vertically laid brown glazed ceramic tile to the side of each door. Each entrance has a double aluminum-framed glass door with a glass transom above and side lights. A series of three bubble-style acrylic skylights is above each entrance. Two secondary entrances consisting of flat metal doors are at the north façade. Other than the lights near the primary entrances, the building has no windows.

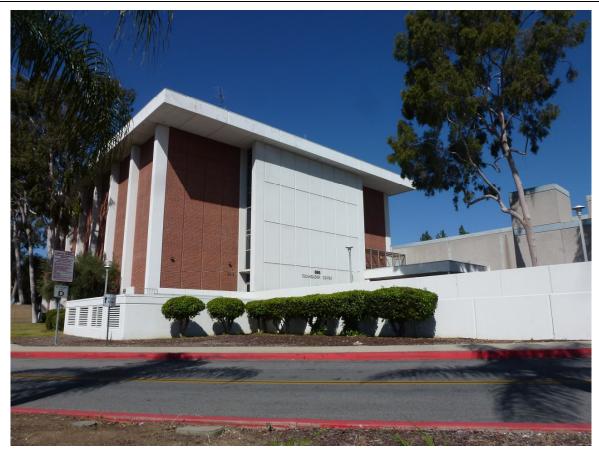
Figure 23. Oblique view of south and east facades of Building 28 A/B.

Buildings 28A and 28B were constructed in 1971 as a single complex to house the Technology Center (Figure 23). The complex has an irregular plan with sections of varying heights. The Modern complex has a flat roof and is clad in red brick with poured concrete with scoring. The east portion of Building 28A is clad in aggregate poured concrete with vertical scoring. There are no eaves, with the exception of the four-story Building 28B to the south, which has a dramatic flat, deep overhang on all four sides. At the west and east façades of Building 28B, a poured concrete slab with a scored grid extends the full height of the building. It is offset from the brick façade, and a door and a vertical row of windows is tucked behind each side of the projection. In contrast, the north and south façades are simple brick-clad walls with squared projecting concrete pilasters extending the full height of the building.

Buildings 28A and 28B appear to be minimally altered, although some of the corrugated concrete sections toward the northeast appear to have been added later. The buildings retain high integrity in all seven aspects.

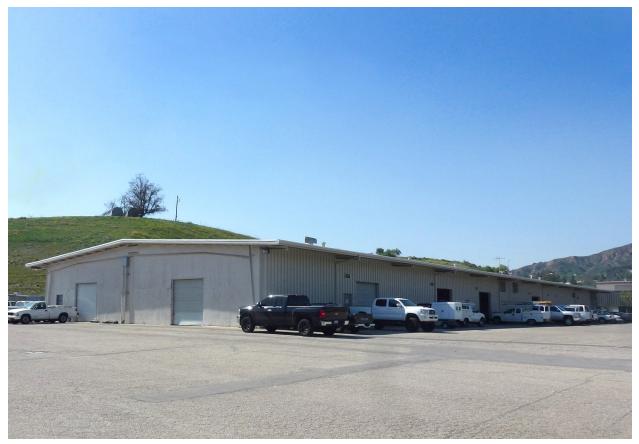
Figure 24. Oblique view toward the west of the northeast and southeast façades of Building 47.

Building 47, the Maintenance and Facilities building, was constructed in 1968 in the Modern style (Figure 24). It is a single-story maintenance building located on the southwest side of Temple Avenue and Service Road on the east side of the Mt. SAC campus. The building has a rectangular floor plan with a concrete foundation. The exterior is clad in baked enamel finished galvanized steel siding with a concrete block bulkhead. The roof is a low-pitched side gable roof with overhanging eaves and clad in metal. The primary entrance is located on the north façade. The windows are primarily aluminum sliding windows. There are also roll-top metal garage doors for maintenance equipment and vehicles. On the gable ends are large steel frames that sit over the steel siding. There is no ornamentation on the building. The interior of the building includes tile and carpet floors with garage spaces and offices.

The center originally included two buildings, as well as parking lots and storage yards. Building 47, with an area of 21,000 square feet, was dedicated to maintenance and operations and included air-conditioned offices, locker rooms, and custodian, grounds, plumbing, heating-ventilating, electrical, paint, and carpenter shops. Building 48, with an area of 34,450 square feet, was dedicated to transportation and receiving-distribution. It included offices, a large warehouse, hydraulic dock levels, and a three-bay garage with two hoists.

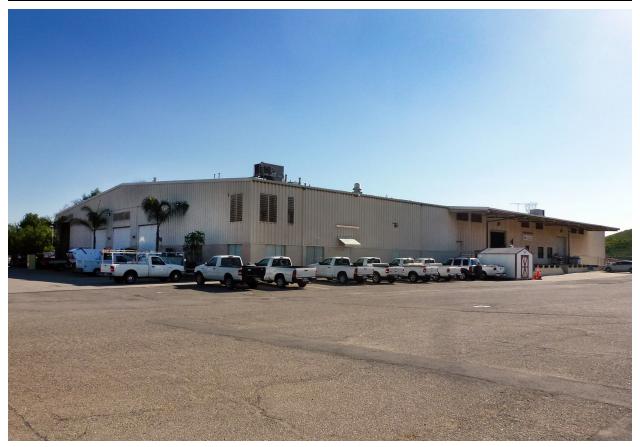
Figure 25. Oblique view toward the south of the northwest and northeast façades of Building 48.

Building 48, the Warehouse and Transportation building, was constructed in 1968 in no particular architectural style (Figure 25). It is a single-story maintenance building located on the southwest side of Temple Avenue and Service Road on the east side of the Mt. SAC campus. The building has a rectangular floor plan with a concrete foundation. The exterior is clad in vertically-oriented steel siding with a concrete block bulkhead. The roof is a low-pitched side gable roof with overhanging eaves and clad in metal. The primary entrance is located on the north façade. The windows are primarily multi-light steel security windows. The building also has metal louvered vents under the roofline and over the roll-top metal garage doors. There is no ornamentation on the building. The interior of the building includes bays for equipment and vehicles as well as a large warehouse space with a concrete floor, a tall exposed metal frame ceiling, and metal shelving for storage.

The building was constructed as the Maintenance and Operations building and was designed to house three offices and warehouse storage space as well as an adjustable dock by the architectural firm Austin, Field & Fry.

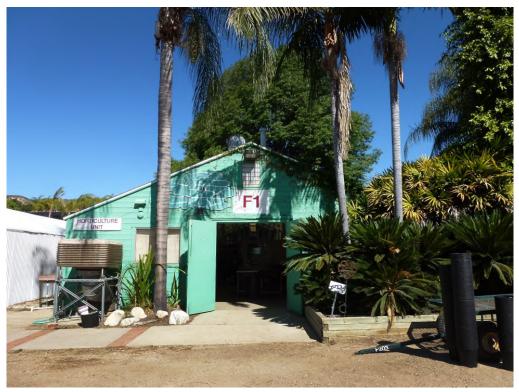
Figure 26. View of the south façade of Building F1.

Building F1, the Horticulture Unit/G3, was constructed in 1959 in no particular architectural style (Figure 26). It is a single-story agricultural building located on the southeast side of Farm Road and Bonita Drive on the east side of the Mt. SAC campus. The building has a rectangular floor plan with a concrete foundation. It has a rectangular, open plan sitting on a poured-concrete foundation. The moderately pitched front-gabled roof is covered in asphalt shingles. Three turban-style aluminum ventilation units sit at the ridgeline of the roof. The walls consist of horizontal wood boards on the lower portion and screens or aluminum slider windows on the upper portion. A Greenhouse (G3) is connected to the north end of the building. The entrance is a flat double metal door at the south façade.

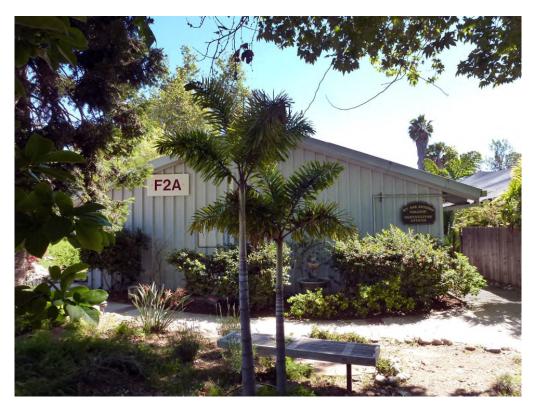
Figure 27. View of the west façade of Building F2A.

Building F2A, the Horticultural Offices, was constructed in 1971 in no particular architectural style (Figure 27). It is a single-story agricultural building located on the southeast side of Farm Road and Bonita Drive on the east side of the Mt. SAC campus. It has a rectangular plan. The front-gabled roof has a small clerestory at the ridgeline and is covered in corrugated metal. Wide eaves at the north and south façades have exposed rafters. There are large centrally located barn-style doors at the west and east façades. The walls and doors are constructed of corrugated metal. Horizontal openings at the top of the south wall are covered in wire screen. The interior is a single open space. It has exposed wood beam ceilings and poured concrete and dirt flooring. Lighting consists of strings of bare lightbulbs. Modifications to the building include the boarding over of windows on the east and west façades with wood paneling, and replacement of the primary entrance door. The building has undergone loss of integrity of materials, design, workmanship, and association.

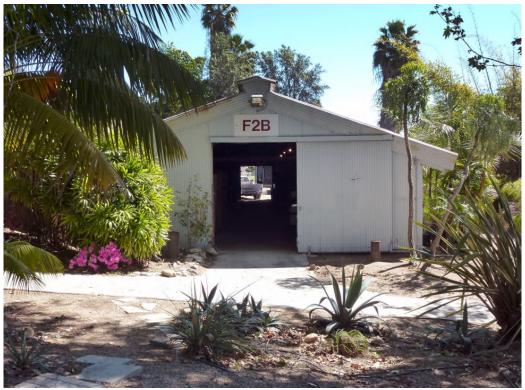
Figure 28. View of the west façade of Building F2B.

Building F2B, the Horticultural Offices, was constructed in 1960 in no specific architectural style (Figure 28). It is a single-story agricultural building located on the southeast side of Farm Road and Bonita Drive on the east side of the Mt. SAC campus. The building has a rectangular floor plan with a concrete foundation. The exterior is clad in corrugated metal sheet siding. The roof is a front gable roof clad in standing seam metal sheets. Wide eaves at the north and south façades have exposed rafters. The primary entrance is located on the west façade and consists of a top hinged sliding metal door. A row of metal-framed windows line the south façade and sit underneath the overhanging eaves. There are no windows on the north façade. The interior is a single open space. It has exposed wood beam ceilings and poured concrete and dirt flooring. Modifications to the building include the boarding over of the north façade with wood paneling, and replacement of the east façade door. The building has undergone loss of integrity of materials, design, workmanship, and association.

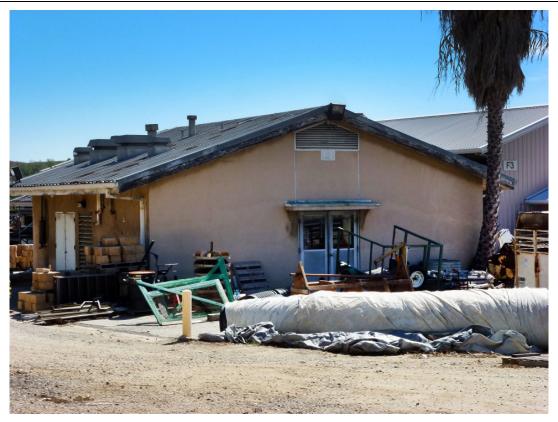
Figure 29. Oblique view of the north and west façades of Building F3A.

Building F3A, the Old Dairy Unit, was constructed in 1960 in no particular architectural style (Figure 29). It is a single-story agricultural building located on the southeast side of Farm Road and Bonita Drive on the east side of the Mt. SAC campus. The building has a rectangular floor plan with a concrete foundation. The exterior is clad in cement plaster siding. The roof is a front gable roof clad in standing seam metal sheets. The primary entrance is located on the west façade and consists of two metal-framed glass door. A row of metal-framed windows line the south façade and sit underneath the overhanging eaves. There are also galvanized metal vertical louvers on the south end of the building that is on the south and north façades. There is a breezeway on the south and north façades that is connected by the continuation of the front gable roof and has a sliding metal door. Modifications to the building include the removal of a concrete wall on the north façade. Despite these modifications, the building retains integrity of materials, design, workmanship, location, setting, feeling, and association.

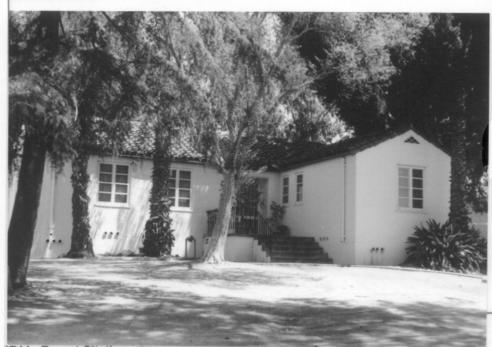
***P3a. Description:** (Describe resource and its major elements. Include design, materials, condition, alterations, size, setting, and boundaries) This is an L-shaped, 2,153-square-foot Spanish Colonial Revival cottage with a gabled tiled roof, stucco walls, and single and double wood casement windows, each side of the casement having four panes. Vents, consisting of a triangular arrangement of six roofing tiles, appear in the gable-ends. The front door, with an ornate wooden screen, is recessed on the east end of the westerly leg of the "L". It is approached by a flight of concrete steps with a wrought-iron railing. A stucco chimney, capped with an arch, appears on the west end of the house. There is a small wing that juts out at the northeast corner of the building. It has a cut-out plaster grille over a recessed window on the west end of its south façade.

P5b. Description of Photo: (View, date, accession #) West and south sides, looking northeast

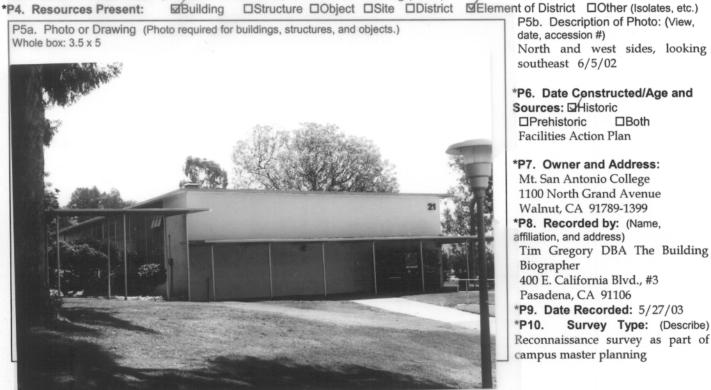
*P3a. Description: (Describe resource and its major elements. Include design, materials, condition, alterations, size, setting, and boundaries) This is a plain, 1 ½-story flat-roofed rectangular building of 7,205 square feet designed in a contemporary style of form following function. Its westerly side is plain stucco with a flat-roofed outdoor passageway along the entire façade (which links it with Building 20), the roof of which is roof supported by slender metal poles. The northerly façade has bands of continuous steel transom multi-paned windows, each with 27 panes. The southerly façade consists of a solid wall onto which open solid classroom doors. The outdoor hallway that runs along this façade is sheltered by a continuation of the flat roof of the west façade. Bands of eight-panedwindows, arranged in groups of three separated by pilasters, appear above the hallway roof. These windows have all been painted over and are partially obscured by the ducts of a later-added air-conditioning system.

This building was designed and built in 1948 by the campus architect Frederick H. Kennedy, Jr. An addition with walls of corrugated-metal and brick has been added to the east end of the building. The original building has fairly good integrity despite evidence of deferred maintenance.

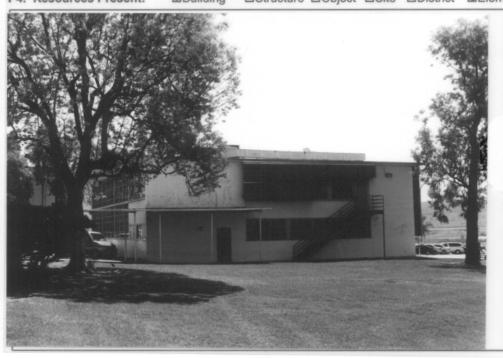
*P3a. Description: (Describe resource and its major elements. Include design, materials, condition, alterations, size, setting, and boundaries) This is a 6,419-square-foot two-story square utilitarian building designed in a contemporary style. It has a flat roof, steel sash, and stucco walls. On the west (front) side are bands of windows on each floor -9 panes each on the first floor and 12 panes each on the second floor. The north side has a band of three 20-paned transom windows on the west end of the second floor and a band of nine taller windows, each with 44 panes, on the east end that covers both floors. The rear (east) side of the building was once open but is now covered with movable sections of vertical wood siding. Large metal horizontal louvers cover all the windows on the south side of the building.

Built in 1948, this building was designed by campus architect Frederick H. Kennedy, Jr. Integrity is good.

P5b. Description of Photo: (View, date, accession #) West and north sides, looking southeast 6/5/02
